SAFETY BULLETIN No. SD-1/008a

Concerning: All SD-1 airplanes up to SN 135

Subject

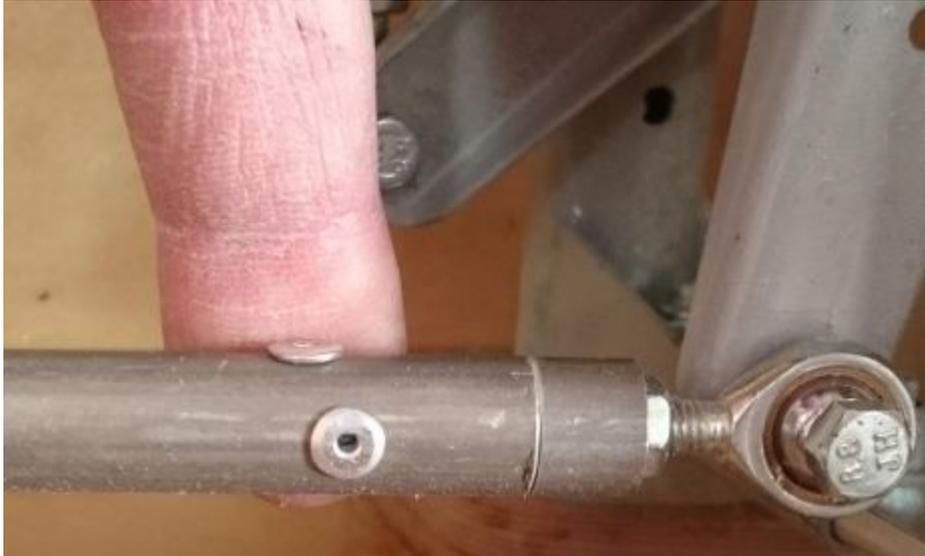
Reason: There were found loosen rod end riveting joints on some airplanes especially in the flaperon controls linkage. There is danger of rivets sheer during continuing operation. This problem is caused by wide production tolerance of aluminium alloy tube ID used in the controls. There are airplanes in the service with TT over 800 hours without any findings.

1. Remove seat from the place
2. Remove fuselage side covers
3. Using sufficient light source check possible movement between tube/rod end/rivets by pulling joint as shown on the bellow picture

Action 1: Checking of all push-pull rod ends riveting for loosen joints.
